GT Refresh Overview of Product Changes

GMI Sales Awareness 8th October 2020

Corrective Actions – Flow Path

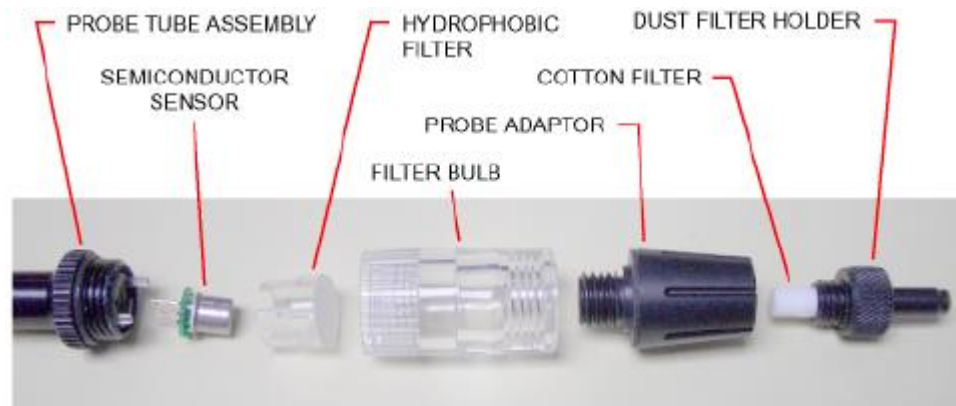
Old design

Problem:

Pumps failing in the field. Pump line blocked with dust and debris.

Root Cause:

Bulb filtering did not provide a satisfactory seal. It allowed dust/debris particles to bypass the filter. This resulted pump performance degradation or failure.

Corrective action: CN6084/6157

Redesigned bulb assembly to improve filtering to prevent dust/debris entering the flowpath.

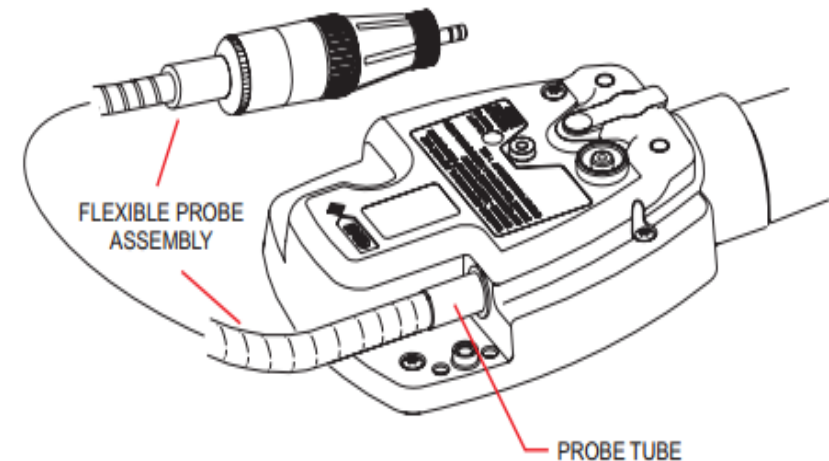
Problem:

Loose probes, broken probe wires.

Root Cause:

Probe held by a grub screw. Grub screw is not sufficient to hold the probe with repeated movement. Causes the probe to come loose and can cause the internal wires to break.

Correction:

As part of maintenance regime probe glued in position on existing instruments

Corrective action: CN6363/6381

Probe glued in position on new builds.

A new spare rear assembly made with probe glued in position.

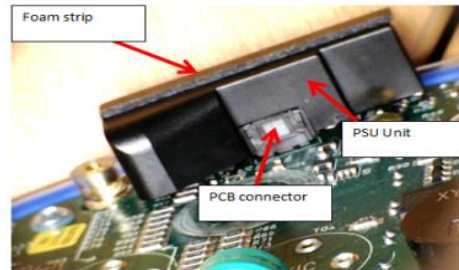
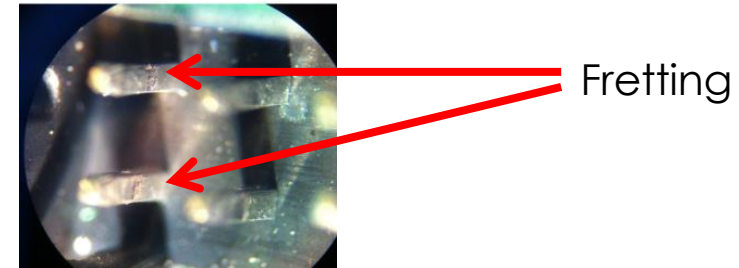
Problem:

Various power failures would appear or disappear depending how tightly the housings were pressed or screwed together.

Root Cause:

Signs of fretting between mating connectors of PSU.

Pump causing movements/vibrations resulting in fretting on tin plated contacts

Correction:

PSU contact cleaning process implemented

Corrective action: CN6366

Gold connectors less prone to fretting. PSU connectors updated to gold plated parts. Implemented foam strip to immobilise the PSU.

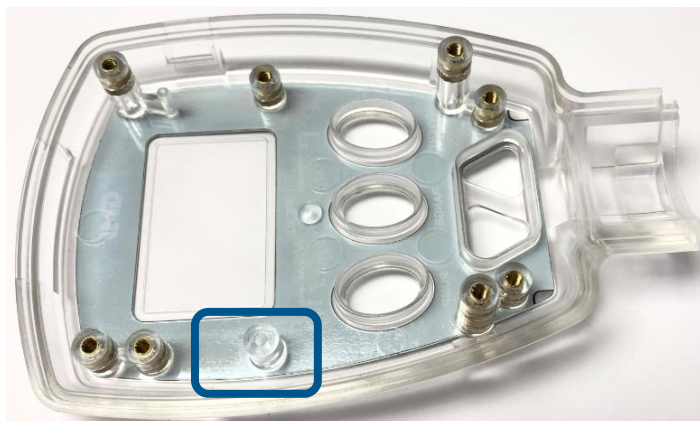
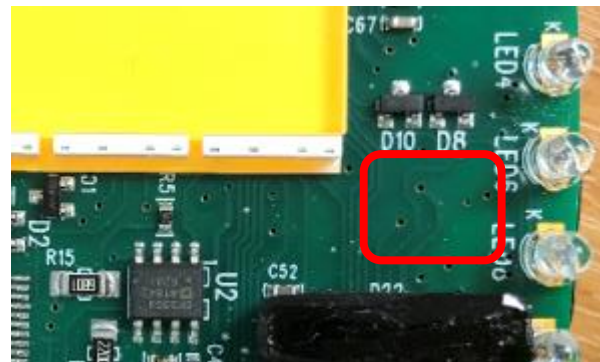
Problem:

Bead Fault/Wrench on LEL range. The failure would appear or disappear depending how strongly the housings were pressed or screwed together.

Root Cause:

Brass insert in position but is not needed. Brass insert was flush and could result in a short circuit across PCB tracks when the instrument is compressed/assembled.

The tracks at risk of being shorted are "BEAD SENSE" to GND. This would imply the sensor is faulty where it is not.

Corrective action: CN6390

Removed insert at position shown on below. **Implemented May 2014**

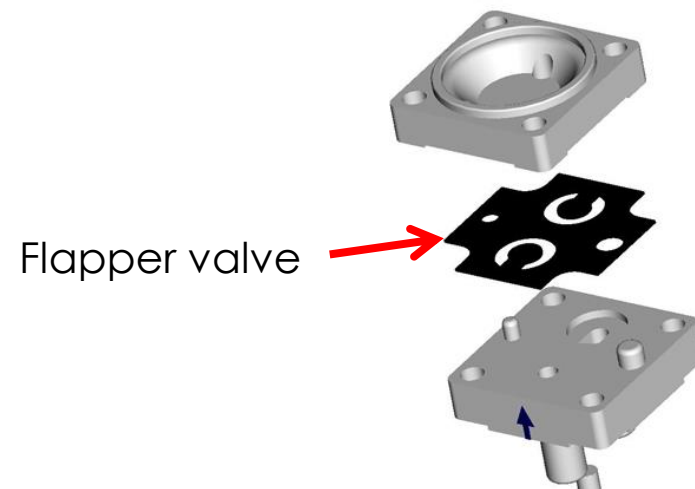
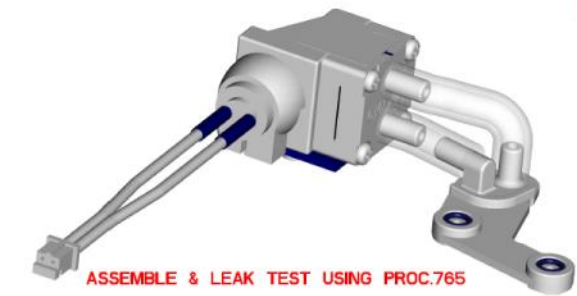
Problem:

Variation in pump performance.

Root Cause:

Rubber pump flapper valve is chlorinated. The chlorination is intended to make the rubber more robust. However, the chlorination process is not easily controlled, results in variation in the rubber flexibility affecting the pump performance.

Corrective action:

- Pump flapper valve changed to unchlorinated material. Long term testing showed no deterioration in pump performance.
- Assembly methods reviewed.
- Production visual management tools implemented to monitor pump yield.
