GT Refresh

Overview of Product Changes

GMI Sales Awareness 8th October 2020

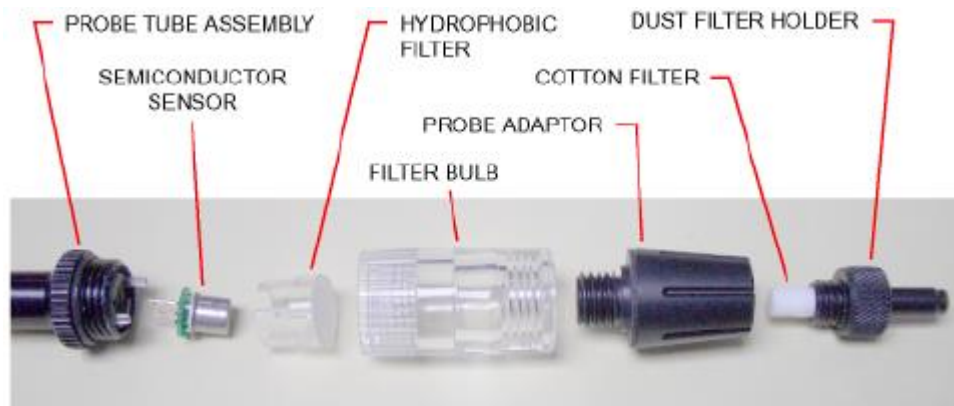
Old design

Pumps failing in the field. Pump line blocked with dust and debris.

Bulb filtering did not provide a satisfactory seal. It allowed dust/debris particles to bypass the filter. This resulted pump performance degradation or failure.

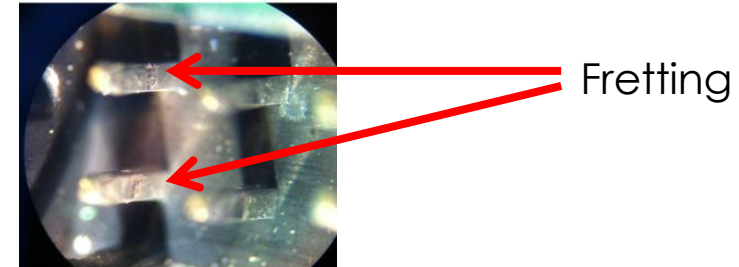
Various power failures would appear or disappear depending how tightly the housings were pressed or screwed together.

Signs of fretting between mating connectors of PSU.

Pump causing movements/vibrations resulting in fretting on tin plated contacts

PSU contact cleaning process implemented

Corrective action: CN6366

Gold connectors less prone to fretting. PSU connectors updated to gold plated parts.
Implemented foam strip to immobilise the PSU.

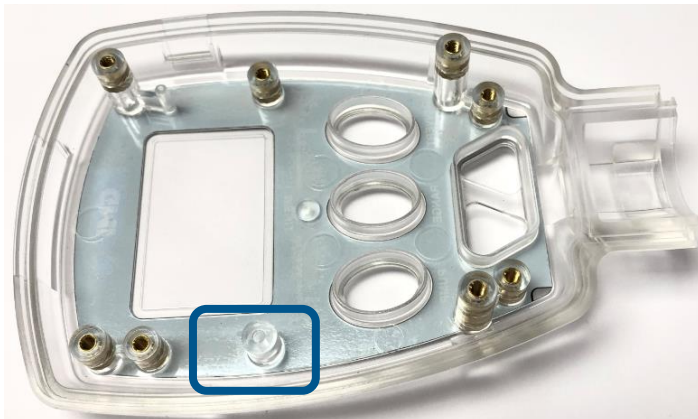
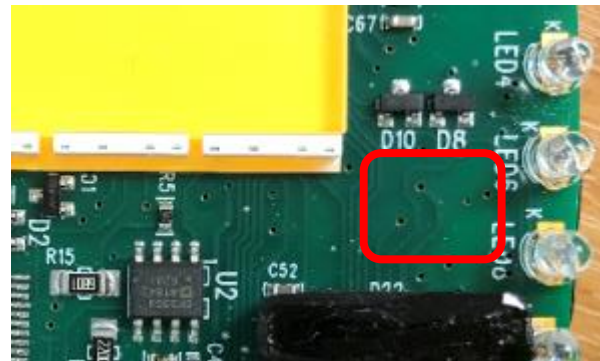
Bead Fault/Wrench on LEL range. The failure would appear or disappear depending how strongly the housings were pressed or screwed together.

Brass insert in position but is not needed. Brass insert was flush and could result in a short circuit across PCB tracks when the instrument is compressed/assembled.

The tracks at risk of being shorted are "BEAD SENSE" to GND. This would imply the sensor is faulty where it is not.

Corrective action: CN6390

Removed insert at position shown on below. **Implemented May 2014**

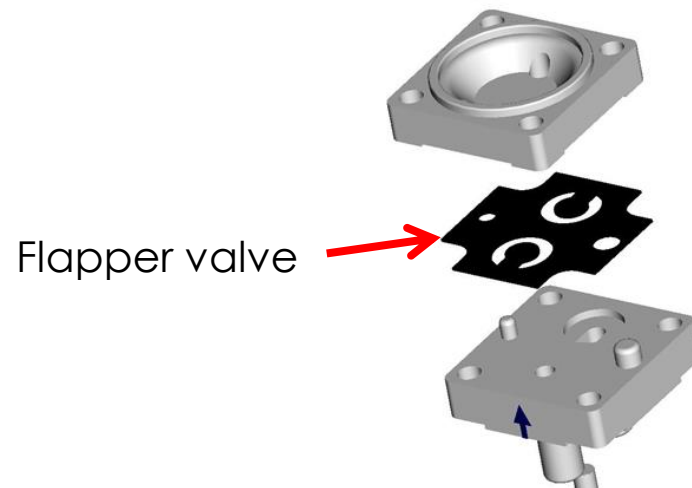
Variation in pump performance.

Rubber pump flapper valve is chlorinated. The chlorination is intended to make the rubber more robust. However, the chlorination process is not easily controlled, results in variation in the rubber flexibility affecting the pump performance.

- Pump flapper valve changed to unchlorinated material. Long term testing showed no deterioration in pump performance.
- Assembly methods reviewed.
- Production visual management tools implemented to monitor pump yield.
